Headliner Area

How to use this manual.

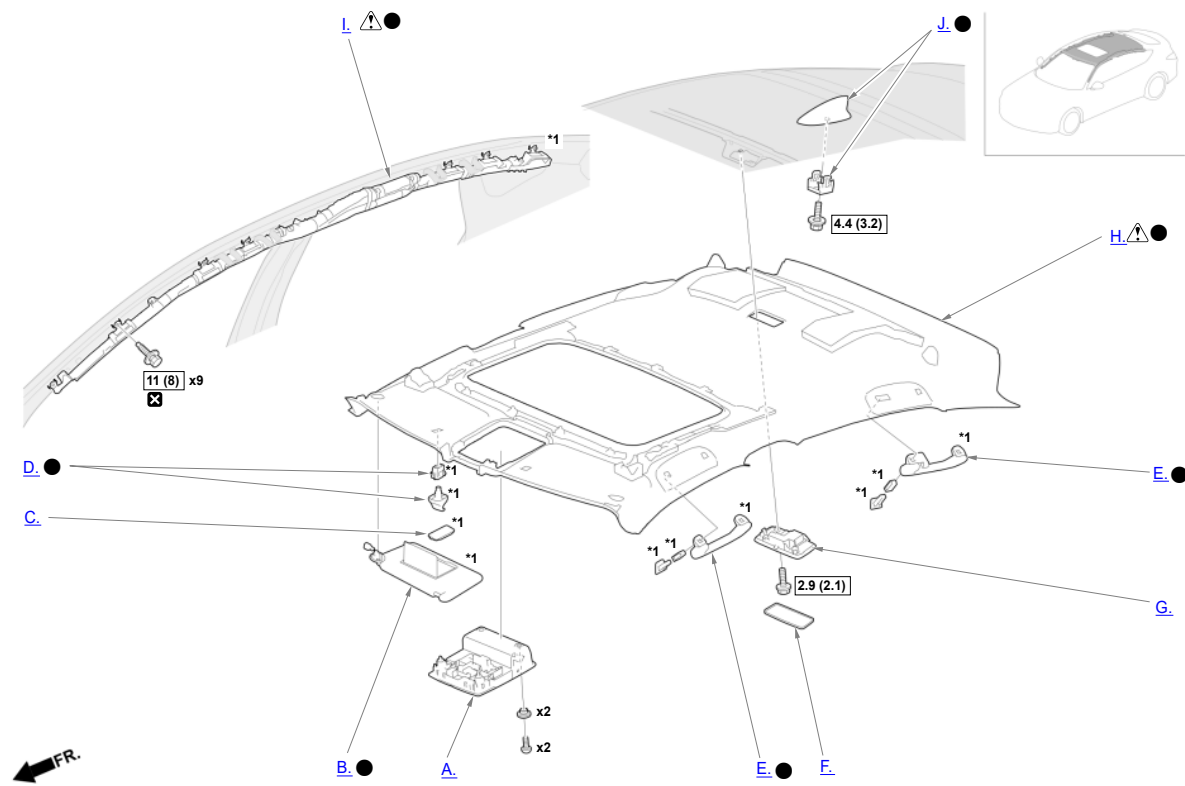
1

\*1: Part(s) are shown for one side only as the procedure is the same for both sides.

- 1. Side Curtain Airbag
- 2. Roof Antenna
- 3. Headliner
- 4. Rear Grab Handle
- 5. Ceiling Light
- 6. Ceiling Light Lens
- 7. Front Grab Handle
- 8. **Roof Console**
- 9. Sunvisor
- 10.Vanity Mirror Light Lens
- 11.Sunvisor Holder
- 12.Middle ANC/Active Sound Control Microphone
- 13.Rear ANC/Active Sound Control Microphone
- 14.Roof Speaker
- 15.Roof Speaker **Grille**
- 16.Front Individual Map Light
- 17.Roof Module
- 18.Front HFL-ANC/Active Sound Control Microphone or HFL Microphone

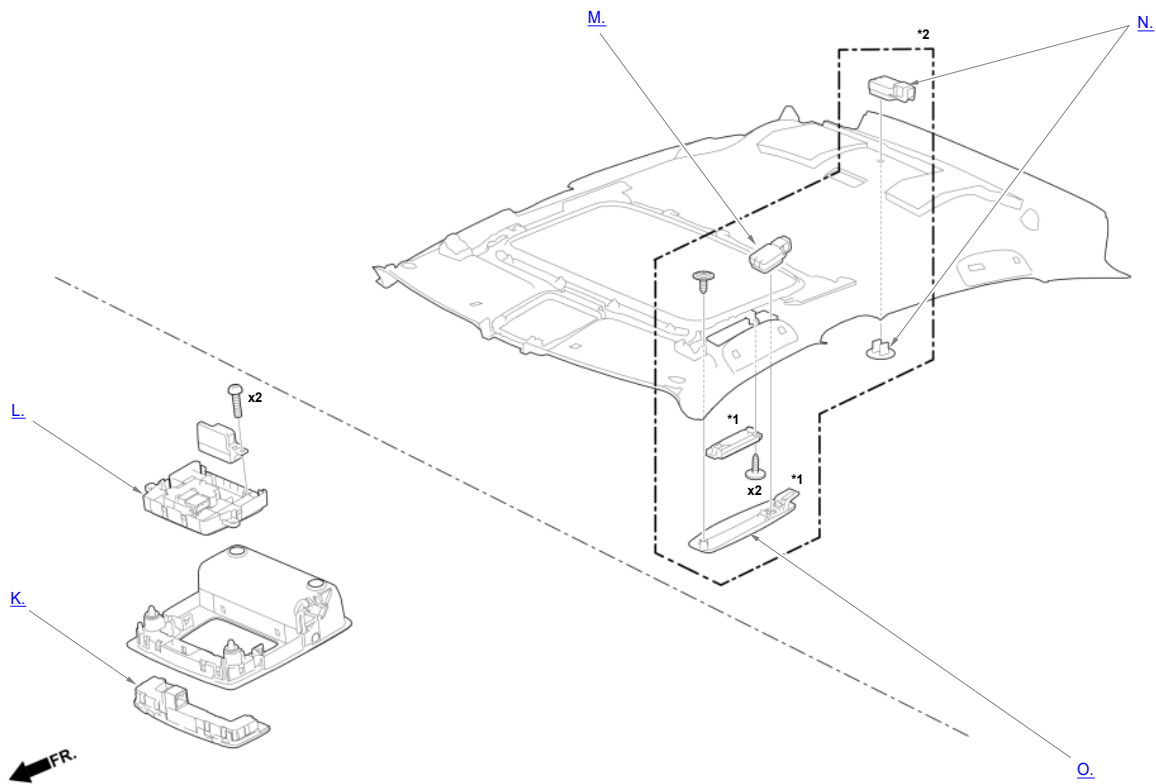
2

\*1: Part(s) are shown for one side only as the procedure is the same for both sides.  
 \*2: Display audio type (9-inch screen)

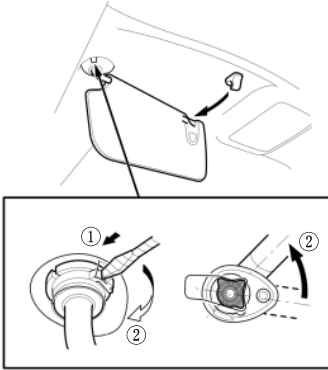
B. -

- Refer to the figure.

- After inspecting the sunvisor, then install the sunvisor.

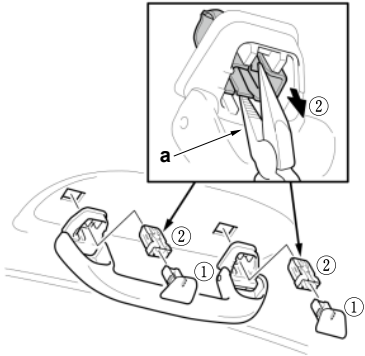
E. -

- Refer to the figure.

| Tool Details | |
|---|---|
| a | Pliers<br>(Commercially Available) |

- After inspecting the grab handle, install the grab handle.

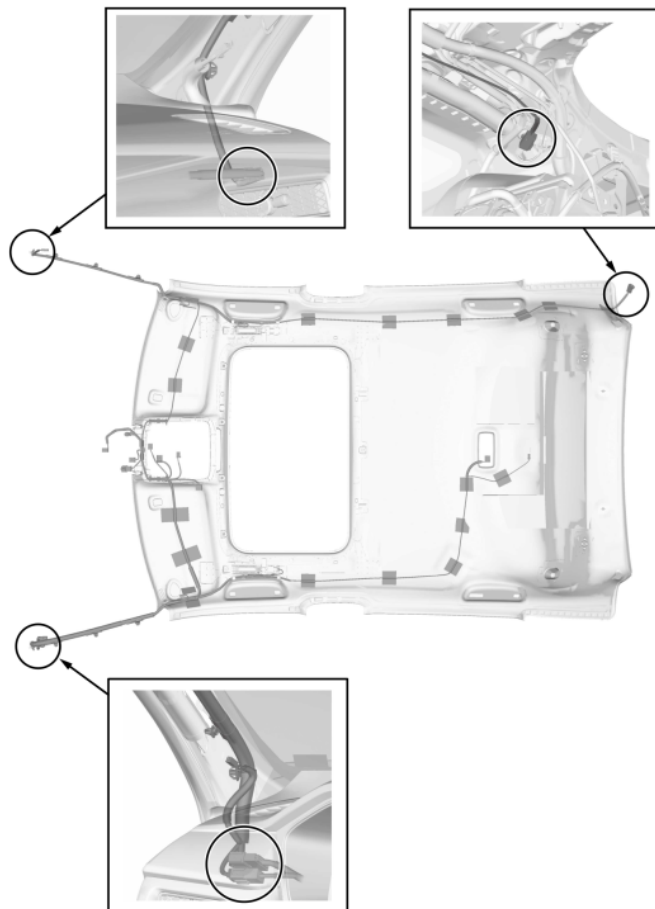
Figure 1

1. Refer to figure 1.

NOTE: The positions and number of connectors vary depending on models.

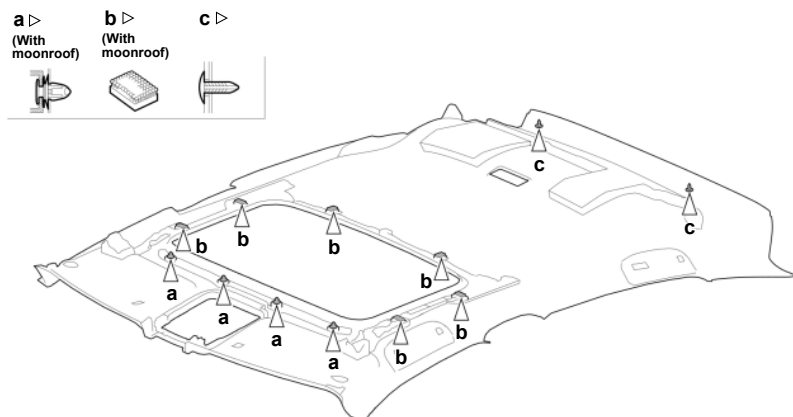
Figure 2

2. Refer to figure 2.

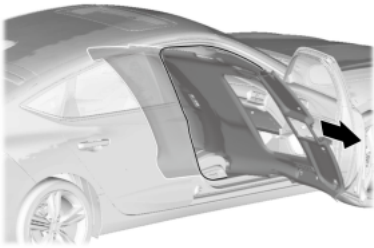
Figure 3

3. Refer to figure 3.

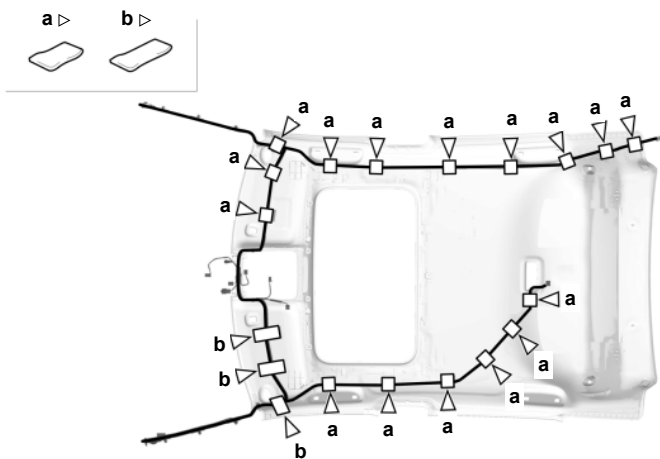
When using a new headliner, check the headliner and the pillar trim overlap.

- After inspecting the headliner, then install the headliner.
- The positions and number of tapes change with models.
- Replace the tapes with new ones.

Figure 4 (Color audio type (7-inch Screen))

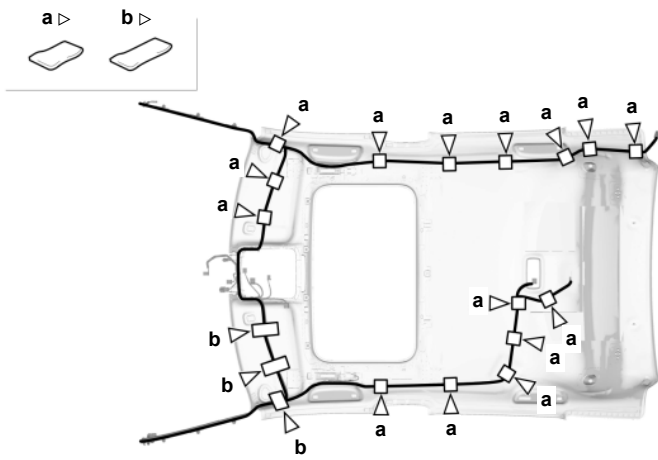
Figure 5 (Display audio type (9-inch Screen))

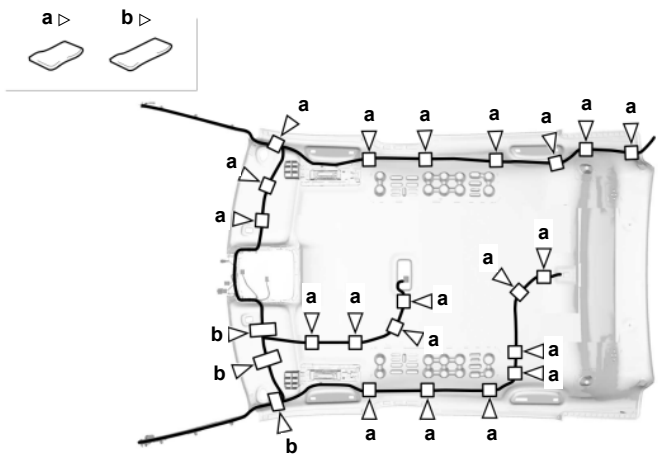
Figure 6 (Without moonroof)

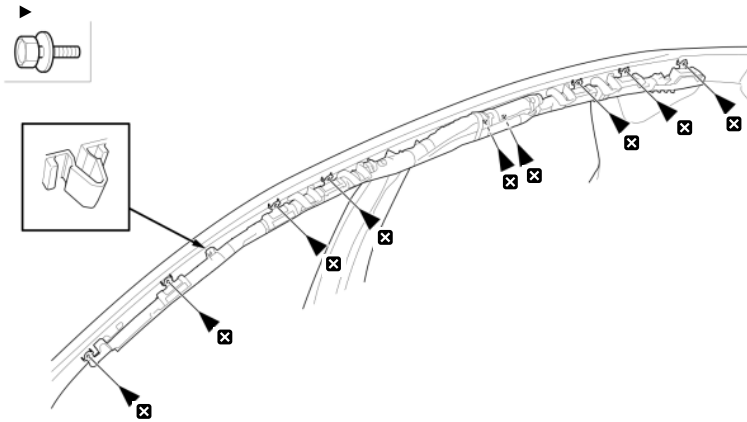
I. -

- Refer to the figure.

- If the side curtain airbag is frayed, or has any other visible damage, replace it. Do not attempt to repair an airbag.
- When you install the side curtain airbag, make sure it is not twisted, and that it is not caught between the inflator bracket by the bracket bolts.
- Make sure that the side curtain airbag inflator retainer is installed properly. Otherwise the side curtain airbag could incorrectly deploy and cause damage or injuries.
- Assemble the wire harness of the side curtain airbag in order not to be caught.
- Apply light force to the inflator and the adapter pipe to make sure there is no excessive play or looseness.
- Before installing the headliner, make sure the SRS indicator works normally.

1. 12 Volt Battery Negative Terminal Reconnect
2. Turn the vehicle to the ON mode, and check that the SRS indicator comes on for about 6 seconds and then goes off.

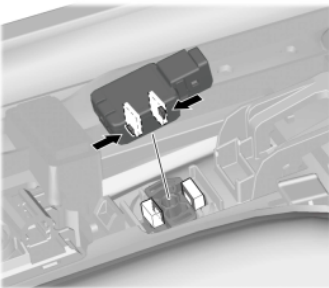
M. -

- Refer to the figure.

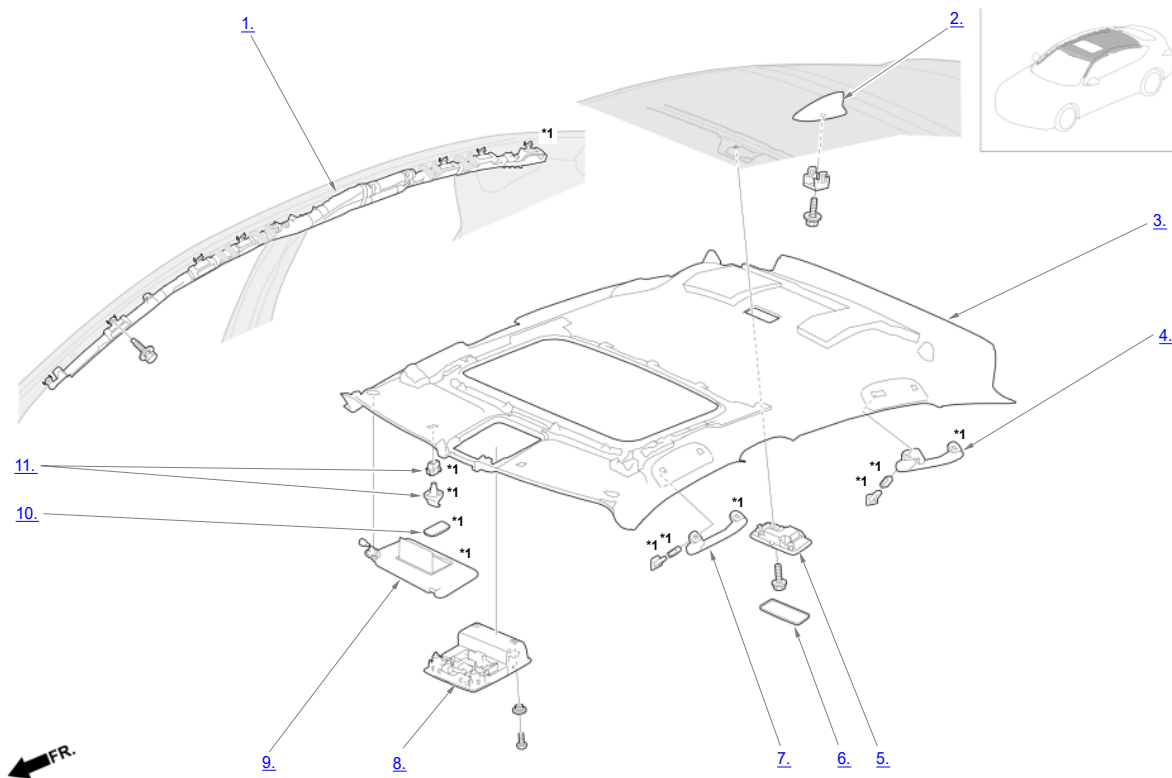
1

\*1: Part(s) are shown for one side only as the procedure is the same for both sides.

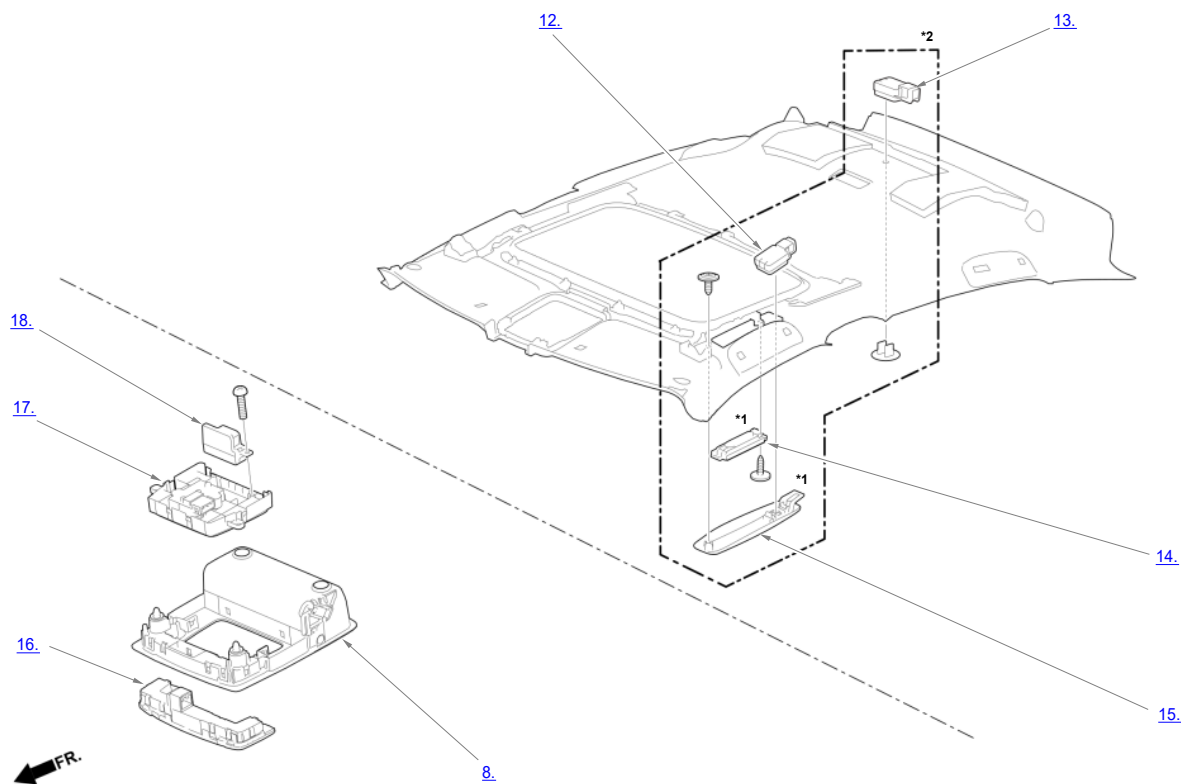
2

\*1: Part(s) are shown for one side only as the procedure is the same for both sides.

\*2: Display audio type (9-inch screen)
