Interior Trim Area

How to use this manual.

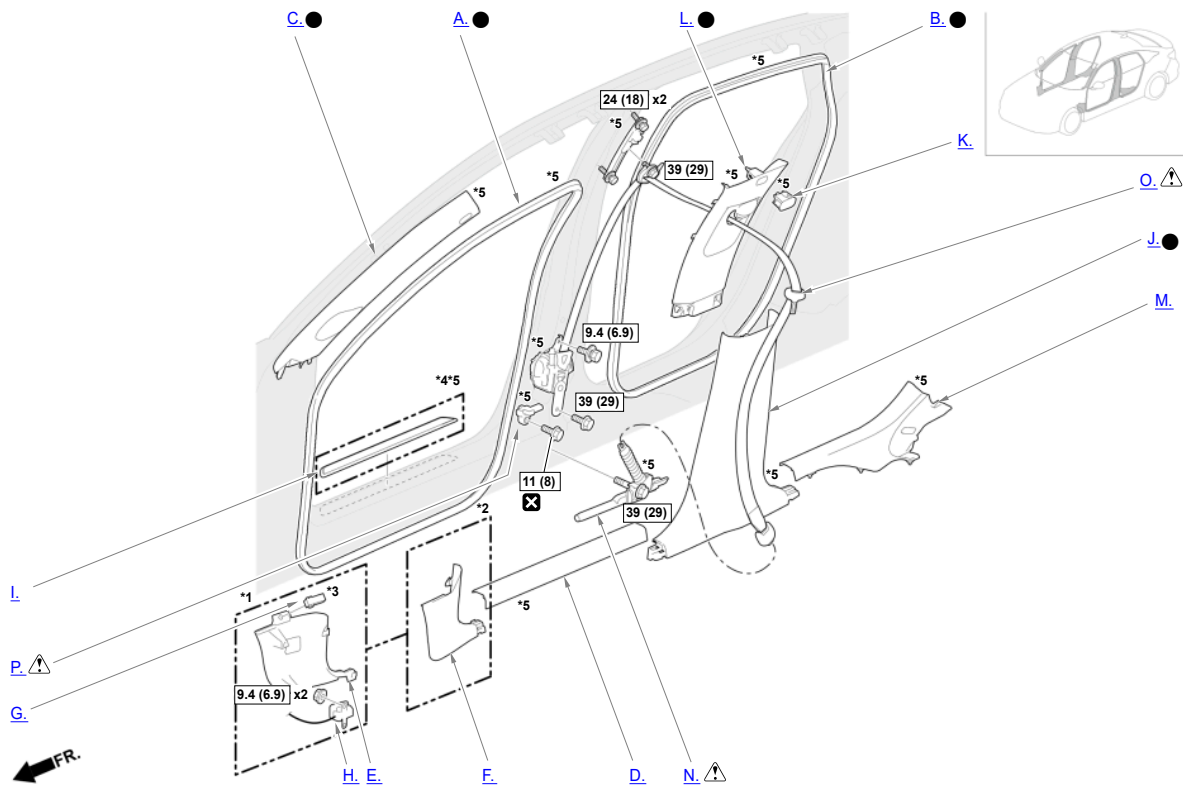
1

*1: Driver's side
*2: Passenger's side
*3: With driver's footwell light
*4: With front side outer trim
*5: Part(s) are shown for one side only as the procedure is the same for both sides.

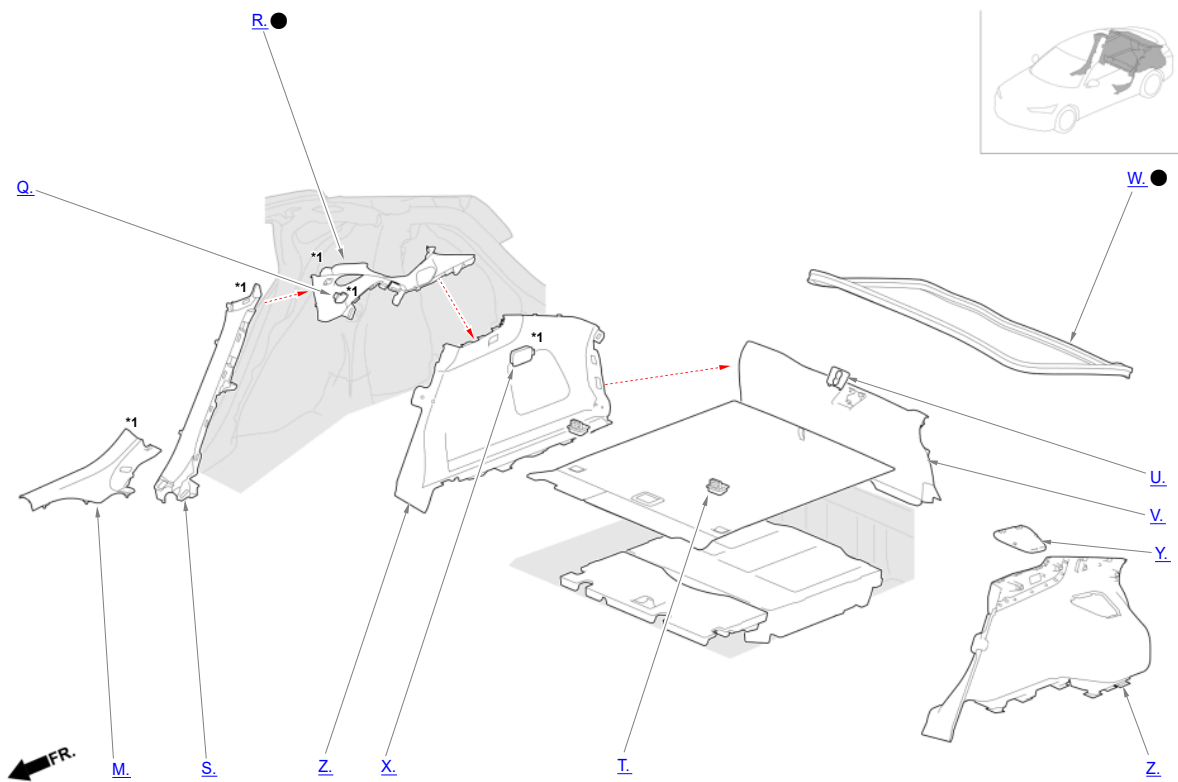
2

*1: Part(s) are shown for one side only as the procedure is the same for both sides.

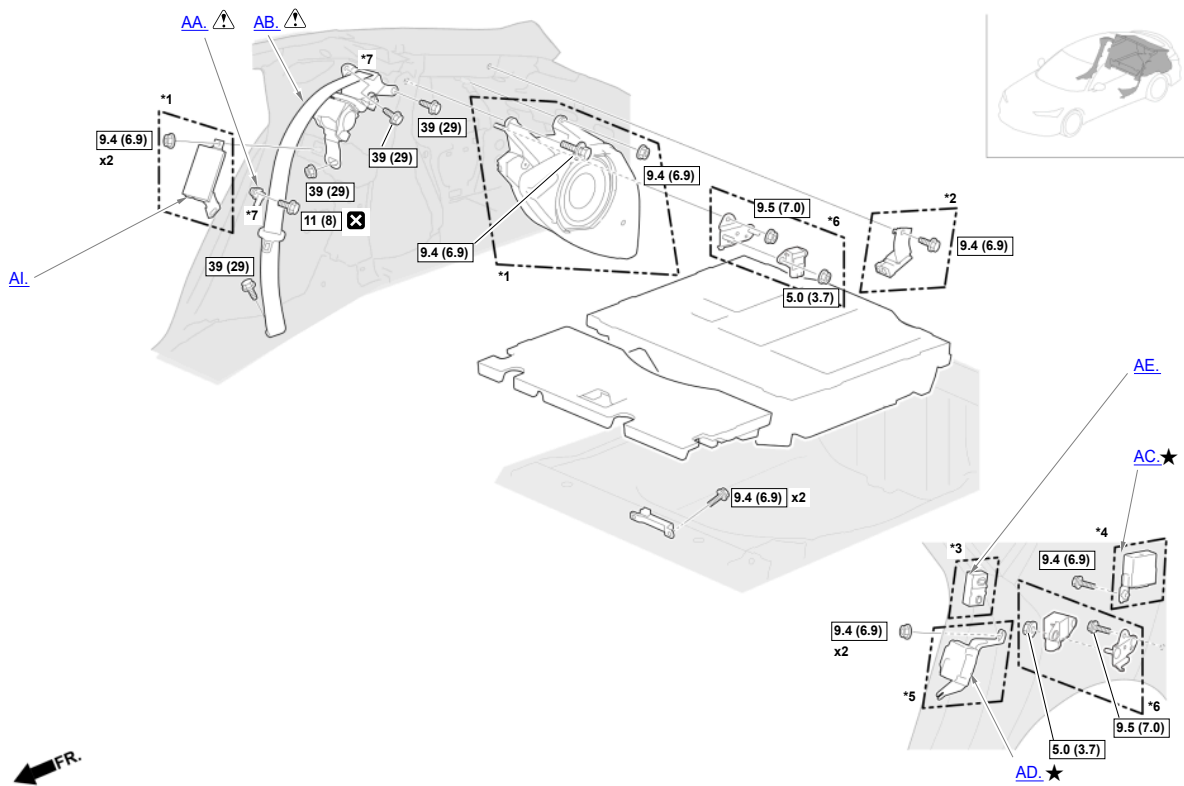
*1: Display audio type (9-inch screen)
 *2: With 2-way transceiver
 *3: With rear seat heater control unit
 *4: With parking and back-up sensor control unit
 *5: With adaptive damper system
 *6: Type-S
 *7: Part(s) are shown for one side only as the procedure is the same for both sides.

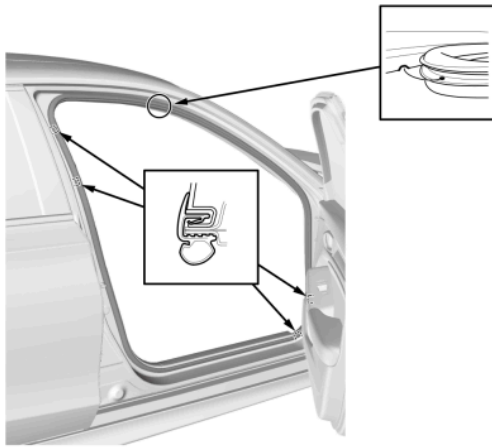
A. -

- Refer to the figure.

- Water Leaks Check

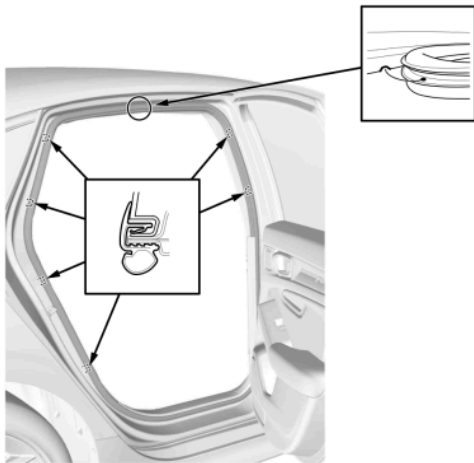
B. -

- Refer to the figure.

- Water Leaks Check

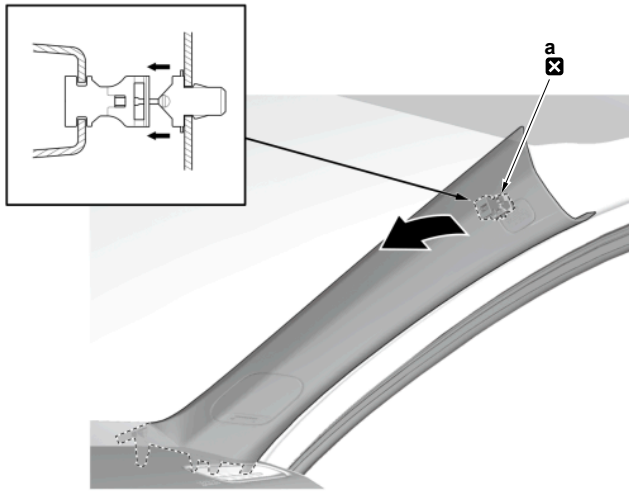
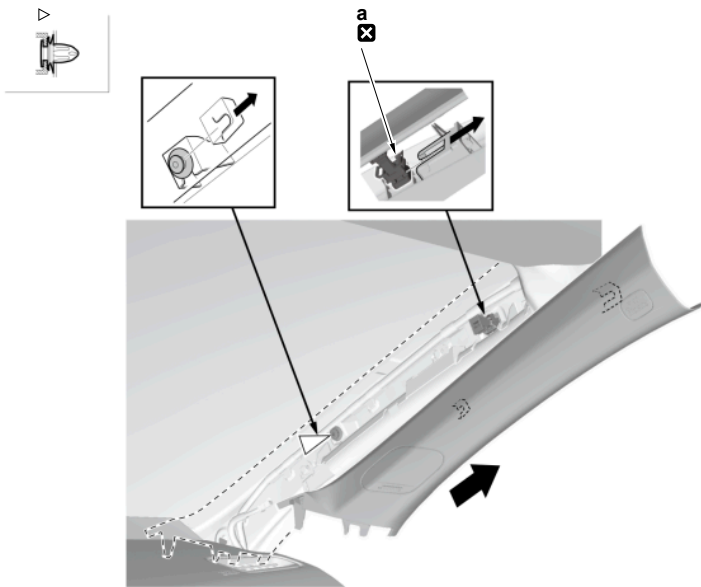
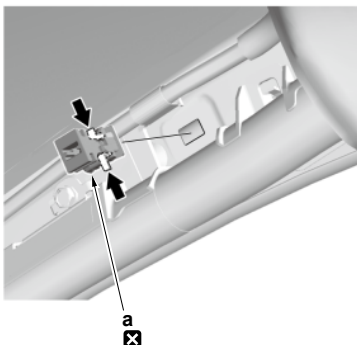
C. -

- Refer to figure 1, 2, and 3.

- Replace the upper clip (a) with a new one.
- The clips will stay in the body.

- Before installing the A-pillar trim, install the clips to the A-pillar trim.
- After inspecting the A-pillar trim, install the A-pillar trim.

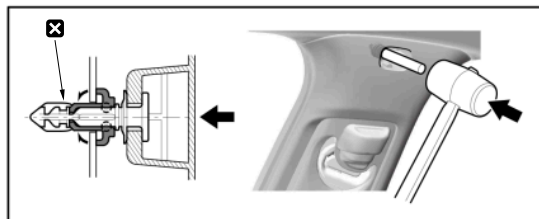
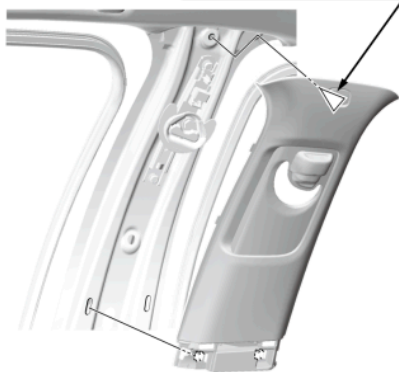
L. -

- Refer to the figure.

1. Replace the upper clip (a) with a new one.
2. After inspecting the B-pillar upper trim then, install the B-pillar upper trim.

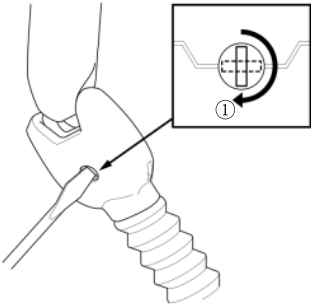
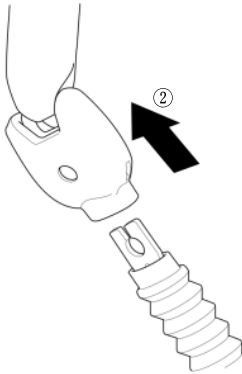
N.-

- Refer to figure 1 and 2.

Before installing the B-pillar lower trim, make sure the SRS indicator works normally.

1. 12 Volt Battery Negative Terminal Reconnect
2. Turn the vehicle to the ON mode, and check that the SRS indicator comes on for about 6 seconds and then goes off.

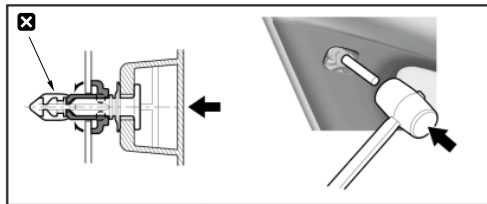
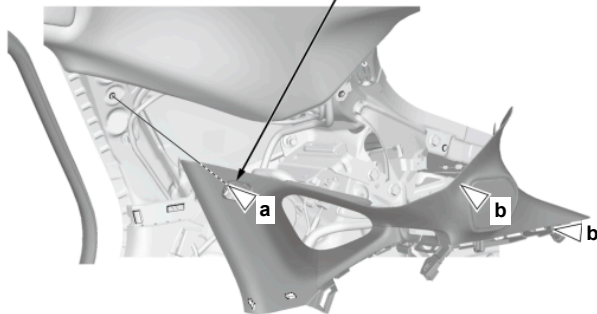
R. -

- Refer to the figure.

1. Replace the upper clip (a) with a new one.
2. After inspecting the C-pillar trim, then install the C-pillar trim.

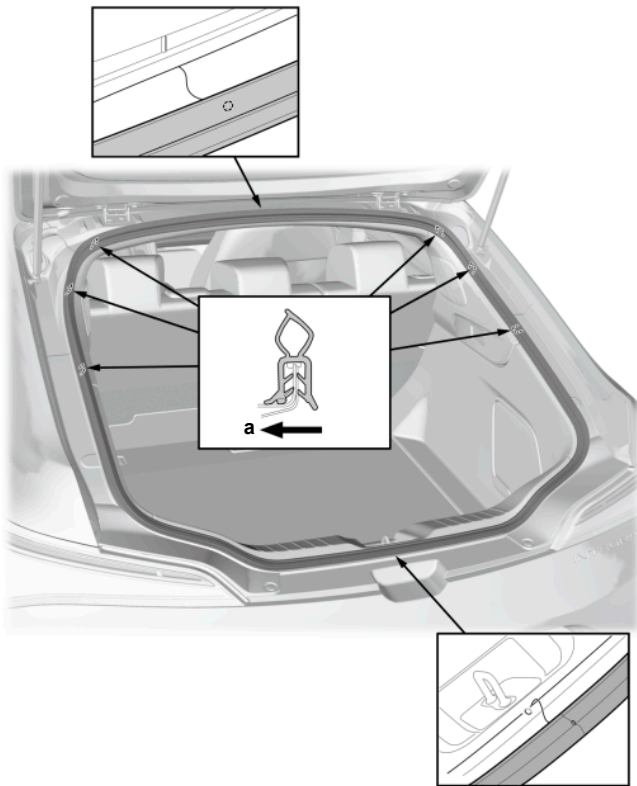
W. -

- Refer to the figure.

Position	Direction
a	Out side

- Water Leaks Check
