INTERIOR TRIM AREA

How to use this manual.

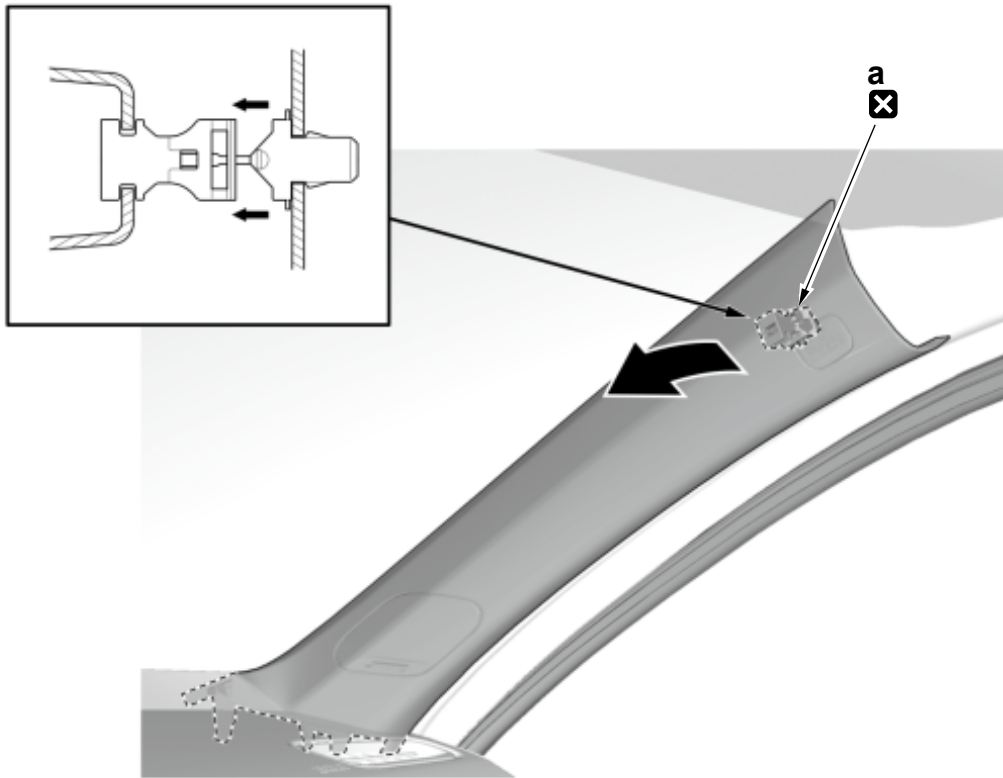
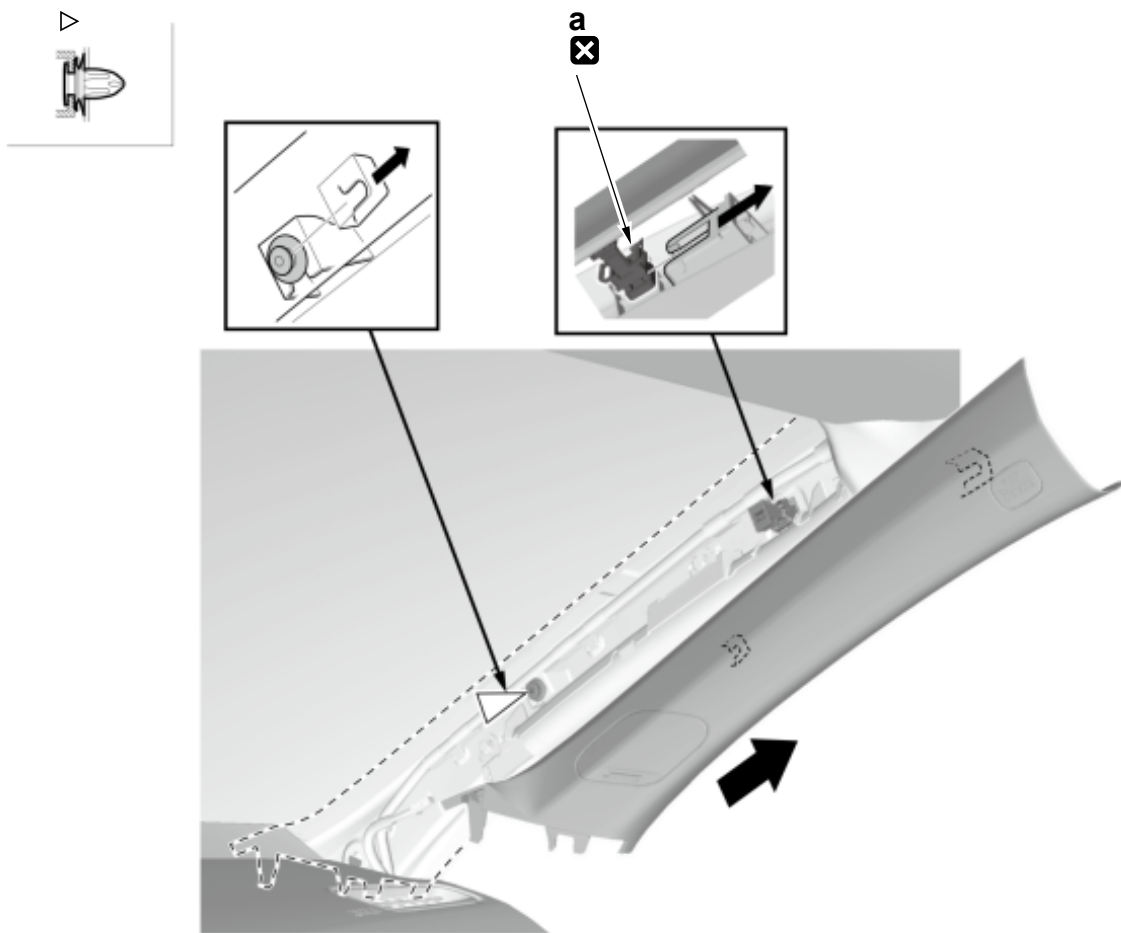
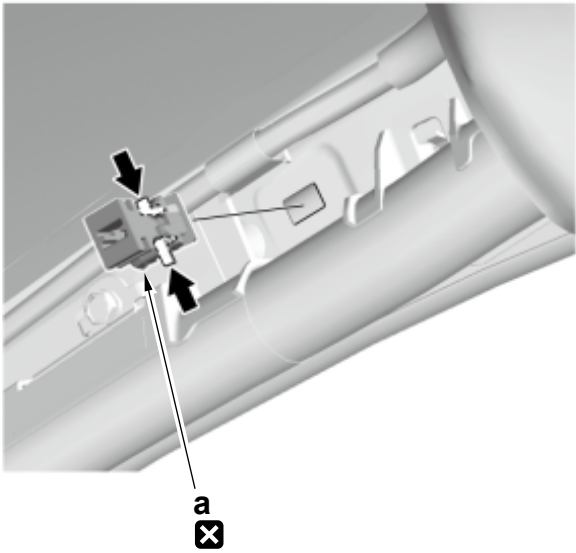
- Refer to figure 1, 2, and 3.

- Replace the upper clip (a) with a new one.
- The clips will stay in the body.

| | • Before installing the A-pillar trim, install the clips to the A-pillar trim. | |
| | • After inspecting the A-pillar trim, install the A-pillar trim. | |

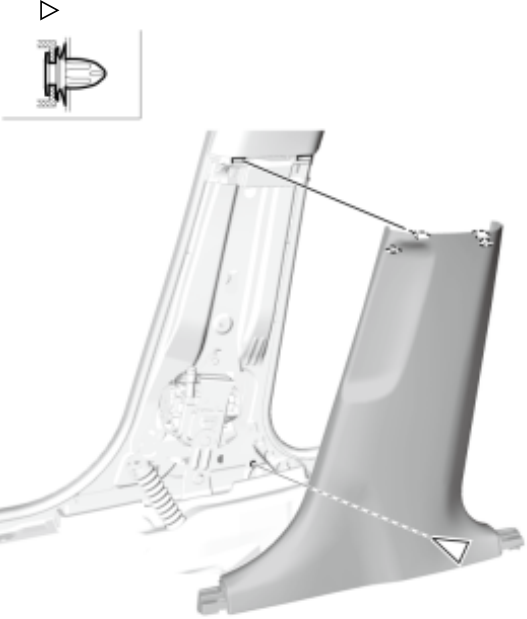
J.

<b>● Removal</b>	
		<ul style="list-style-type: none"> <li>Refer to the figure.</li> </ul>

<b>● Installation</b>	
		<ul style="list-style-type: none"> <li>After inspecting the B-pillar lower trim then, install the B-pillar lower trim.</li> </ul>

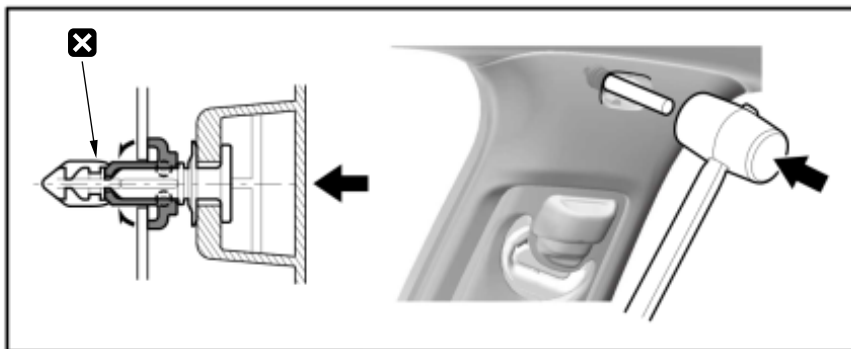
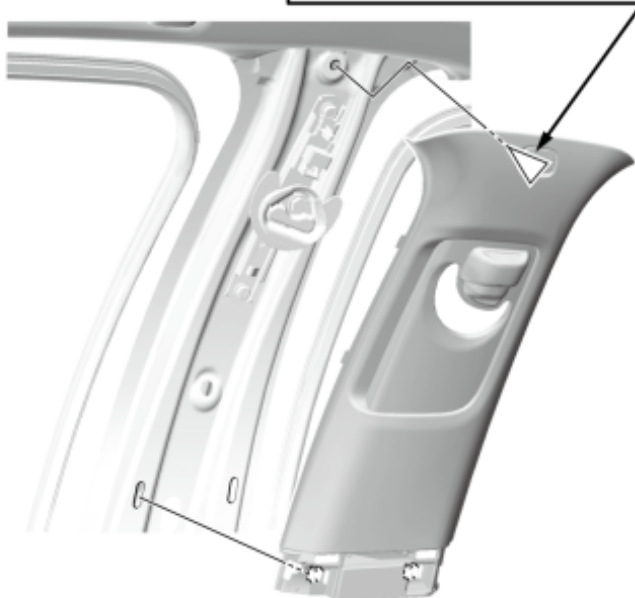
- Refer to the figure.

1. Replace the upper clip (a) with a new one.
2. After inspecting the B-pillar upper trim then, install the B-pillar upper trim.

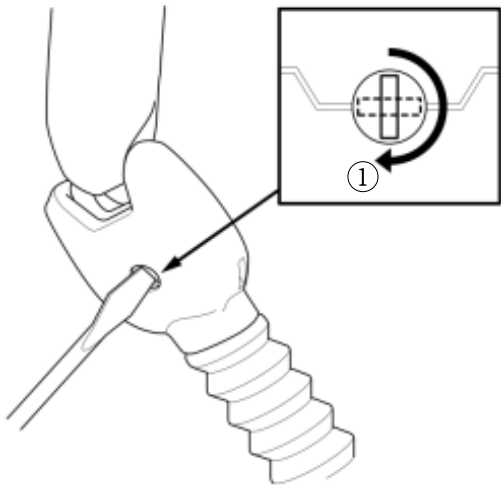
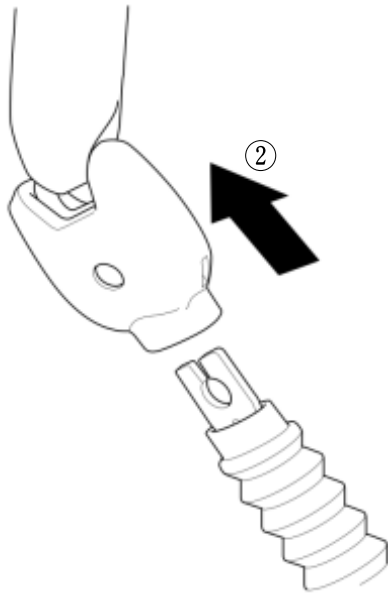
- Refer to figure 1 and 2.

Before installing the B-pillar lower trim, make sure the SRS indicator works normally.

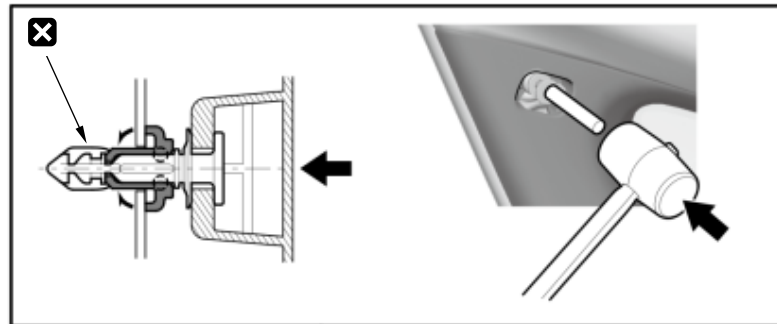
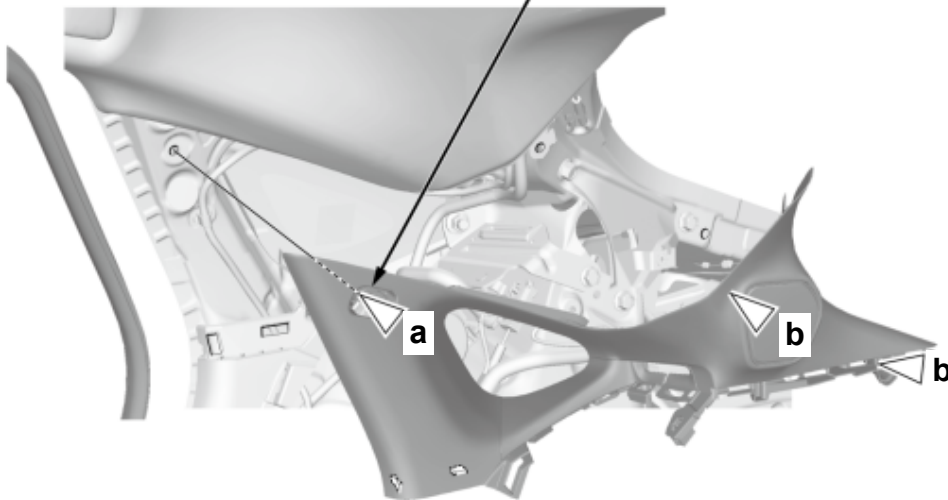
R.

- Refer to the figure.

1. Replace the upper clip (a) with a new one.
2. After inspecting the C-pillar trim, then install the C-pillar trim.

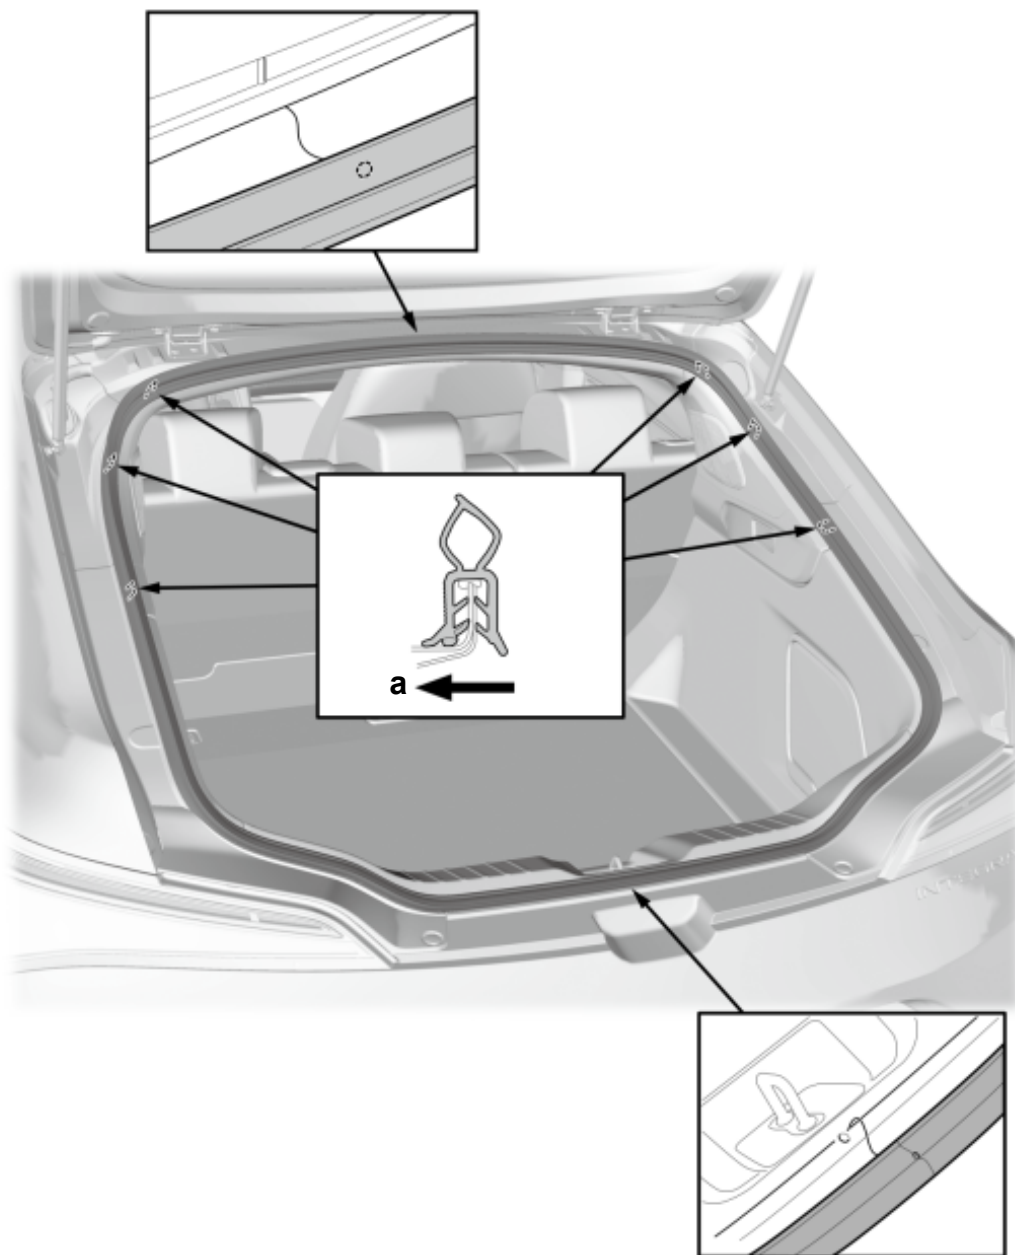
W.

- Refer to the figure.

Installation Directions	
Position	Direction
a	Out side
